**SIDE-CHANNEL SPILLWAY AND OUTLET  
WORKS FOR SAN ANTONIO DAM**

Hydraulic Model Investigation

Report No. 2-106  
October 1978

U. S. Army Engineer District, Los Angeles  
CORPS OF ENGINEERS  
Los Angeles, California

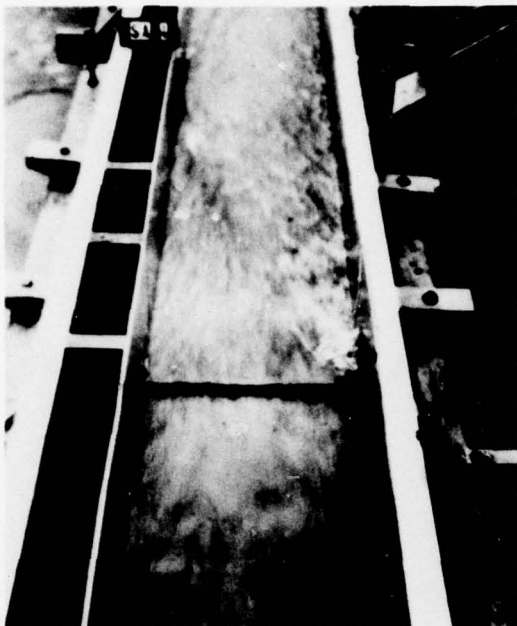
Photo A29. Looking downstream.  
900 cfs in main channel, 400 cfs  
flowing into the diversion struc-  
ture. Spray occurred at right  
wall of entrance to diversion  
structure

8. The main problems of concern were the flow distribution in the curved portion of the diversion channel under the main channel invert and the influence of the curved approach upon the discharge through the gate well. The investigation showed that for most of the discharges, flow conditions in the curved sections and in the section downstream from the gate well were generally satisfactory. The tests were conducted by establishing a sequence of discharges and setting the gate opening to divert a certain discharge. The slot inlet intercepted a maximum discharge of 350 cfs before any flow would continue down the main channel. For flows greater than 350 cfs, with the gate opened and closed, waves were set up in the channel by the slot inlet in the invert that created a spray which covered a wide area. The spray ceased to exist when the discharge in the main channel was greater than 1,000 cfs. A gage installed on the cover of the gate well indicated a maximum pressure head of 15 ft. Visual results at various discharges are shown in Photos A17-A31.

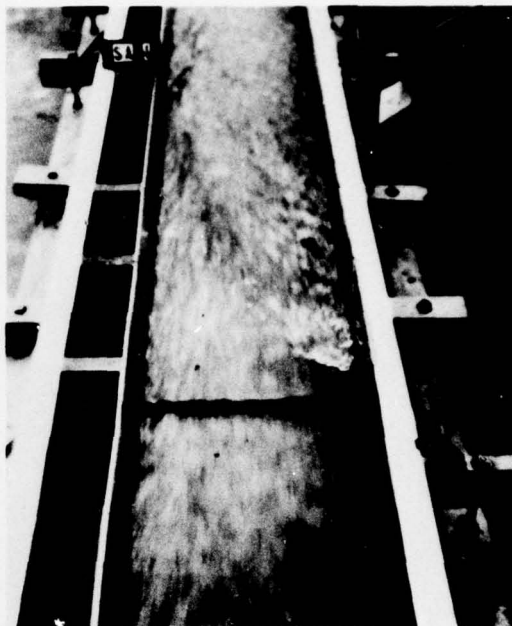
Photo A30. Looking downstream.  
1,100 cfs in main channel, 400 cfs  
flowing into the diversion  
structure

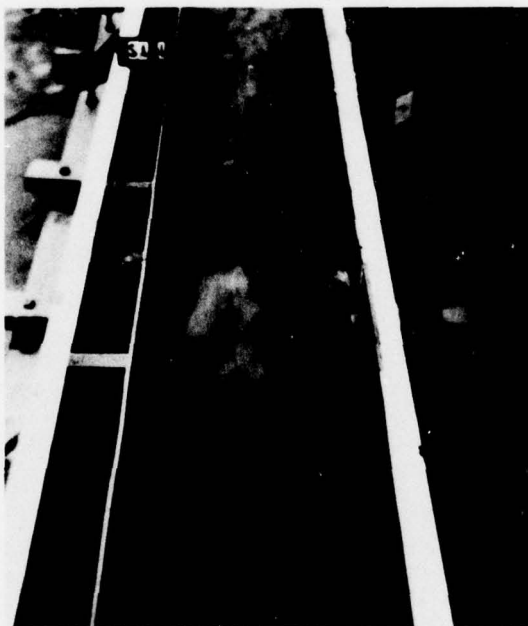
Photo A31. Looking downstream.  
2,000 cfs in main channel, 400 cfs  
flowing into the diversion  
structure

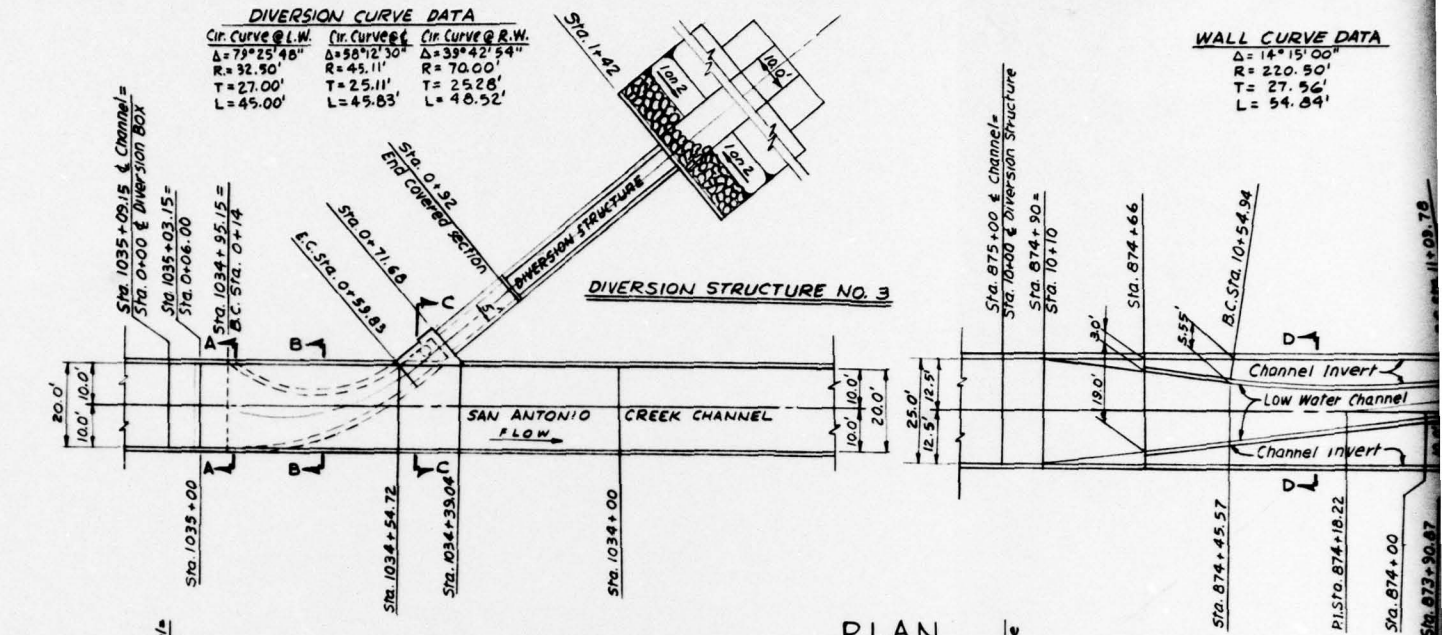
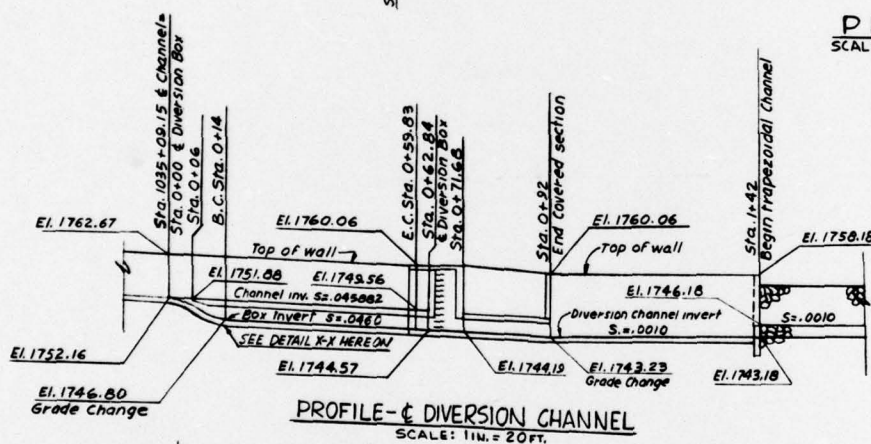
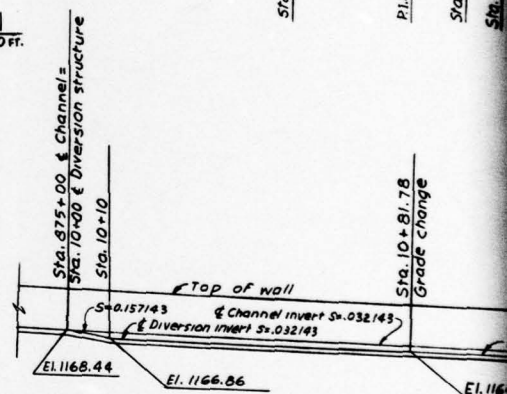
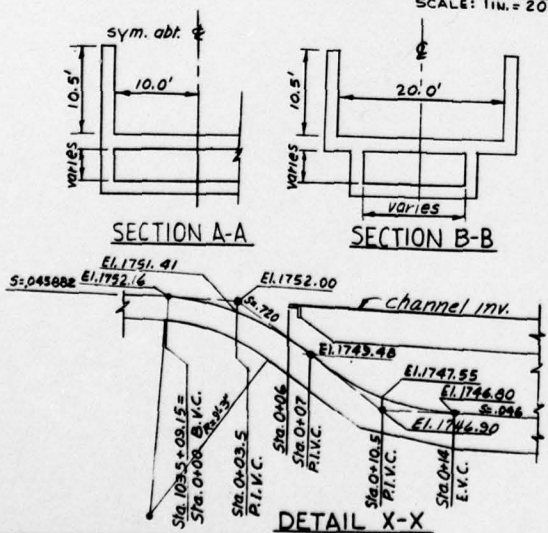
DIVERSION CURVE DATA		
Cir. Curve @ L.W.	Cir. Curve @	Cir. Curve @ R.W.
$\Delta = 79^\circ 25' 48''$	$\Delta = 98^\circ 12' 30''$	$\Delta = 39^\circ 42' 54''$
$R = 92.50'$	$R = 45.11'$	$R = 70.00'$
$T = 27.00'$	$T = 25.11'$	$T = 25.28'$
$L = 49.00'$	$L = 49.83'$	$L = 40.92'$

WALL CURVE DATA
$\Delta = 14^\circ 15' 00''$
$R = 220.90'$
$T = 27.96'$
$L = 54.84'$

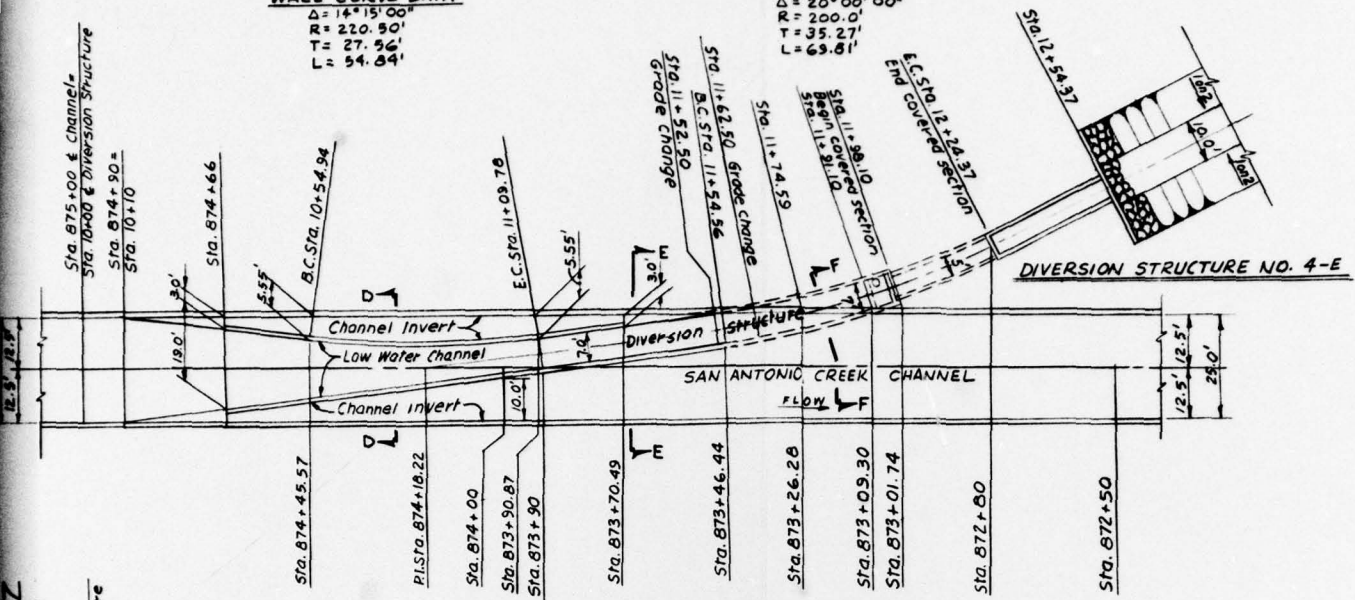
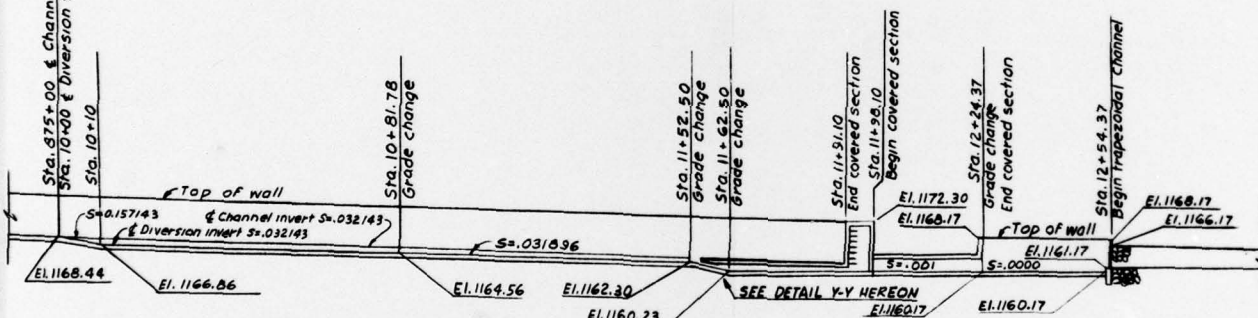
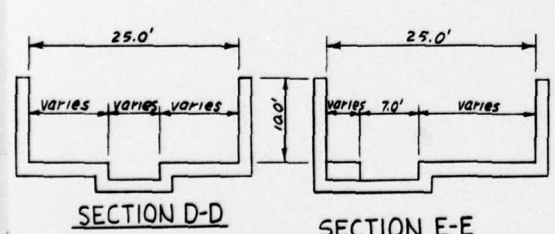
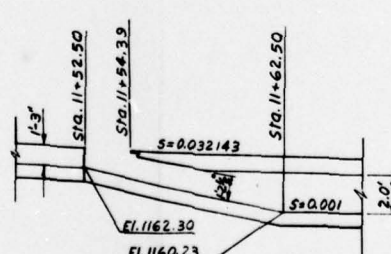
**SAN ANTONIO CREEK CHANNEL  
 DIVERSION STRUCTURES  
 NO. 3 AND NO. 4-E**

Circular Curve  
 $\Delta = 20^{\circ}00'00''$   
 $R = 200.0'$   
 $T = 35.27'$   
 $L = 69.81'$

**PROFILE - E DIVERSION CHANNEL**  
 SCALE: 1" = 20.0'
